Final Report  
for the Period  
September 1984  
to July 1989

# Pulsed Plasma Mission Endurance Test

Authors:  
R.J. Cassidy

Rocket Research Company  
Olin Defense Systems Group  
11411 Willows Road NE  
Redmond WA 98073-9709

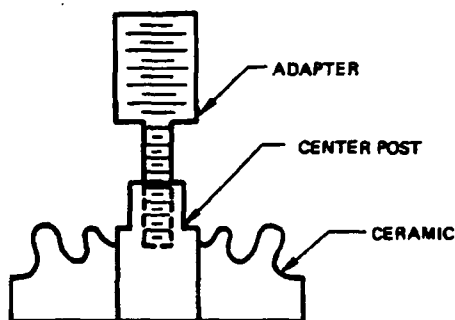
**Fig. 11. Initial Center Post Adapter Design**

When the capacitor housing was removed from the thruster, signs of arcing were apparent near the stripline/capacitor interface. Removal of the stripline revealed a heavy coating of black carbonaceous deposit on the surface of the capacitor insulator. Figure 9 shows the extent of the arcing and the deposit which was formed. This deposit was the source of the high resistance short which was preventing full charging of the capacitor bank. Further examination of the capacitor was made to determine what caused the arcing to occur. The most likely scenario involved the center mounting post adapter. The mounting post adapters were fabricated by RRC after the Sandia capacitors arrived with no center posts. The Sandia capacitor design varied from the Maxwell capacitor design in this regard, which meant that the Sandia capacitors would not interface with the stripline. Figure 10 illustrates the difference between the Maxwell and the Sandia capacitor electrode configurations. Apparently, no specification was included in the Sandia contract with AFAL documenting how the center post should be configured. RRC was faced with the problem of making the capacitors work with the existing stripline and decided upon the simple adapter design shown in Figure 11. This seemed to be an adequate solution, provided two nuts were used to clamp the stripline securely to the center post adapter. In the case of the arcing which occurred at the center post, what had apparently happened was that the lower nut, underneath the stripline, had dropped off the bottom of the 1/4-20 threaded portion of center post adapter, thus breaking the surface contact with the stripline and resulting in an arc.

except through the threaded rod. This 4-40 screw did not have a sufficient cross section to carry the tens of thousands of amperes during the thruster discharge. These findings resulted in a second revision to the adapter design modification and a revised procedure for curing the epoxy insulator material.

This assessment of the incident led RRC to redesign the center post adapter with a mounting shoulder to make contact with the stripline, and with improved contact to the Sandia capacitor center electrode. The revised mounting adapter design is shown in Figure 12. These adapters were fabricated and installed on four of the Sandia capacitors, including the one which had a coating deposited by the arc from the earlier testing. This capacitor had been thoroughly cleaned to remove all visible traces of the deposit. The thruster was reassembled and prepared for another attempt at the start of the test. The next try occurred on August 22, 1986. The chamber was evacuated to  $10^{-5}$  torr backpressure. Upon giving the single shot command to the thruster, internal arcing was observed and the thruster did not fire. No further shots were attempted. The chamber was vented and the thruster was removed for inspection. Inspection revealed arcing had occurred on the same capacitor as the previous incident. As before, a thick black coating covered the top of the capacitor. Close examination revealed that the stripline was deformed into a slight upward bow. Two probable causes were identified for the arcing problems. The first was that stripline deformation dating back to the MDAC capacitor explosion was resulting in poor surface contact with the capacitor. The second was that the capacitor insulator was not capable of holding off the voltage, possibly due to damage incurred during the earlier arcing.
